Air Cleaner Surround for ACE Air Cleaner Canister

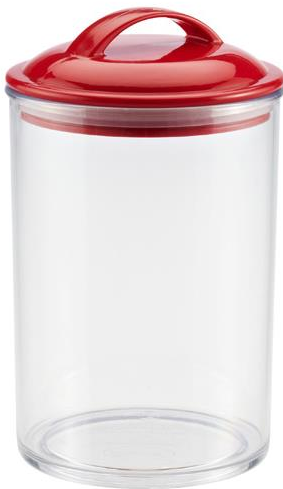
I have an ACE Air Cleaner Canister for my '09 AVL and recently when driving in the rain, had the element become sodden and stop flowing air. As I was driving along the bike began losing power and opening the throttle further had no effect. I first thought wet spark plug, but it was hot and dry. I then unscrewed the lid of the ACE Canister and was off again.

I live in the Dallas, Texas area, and though it does not rain as much as we need, commuting daily on my RE, I needed a more reliable solution. I had been using the OEM aluminum shield that covers the front half of the filter element, but that did not work this time, as the exposed part of the filter became wet, and I imagine the paper swelled, blocking the air flow.

The solution I came up with, is a modified plastic food storage canister from The Container Store, 1.5 qt. Color Pop Acrylic Canister Red Lid, 4-1/2" diam. x 8" h, part number 10059001, for \$13. To accommodate the metal mounting of the ACE Canister, I used a 3" hole saw to remove most of the bottom of the canister and then cut it down to 2-1/4" tall.

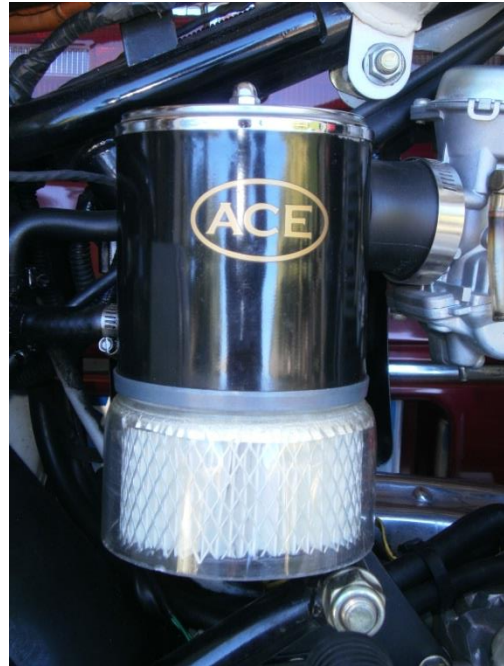
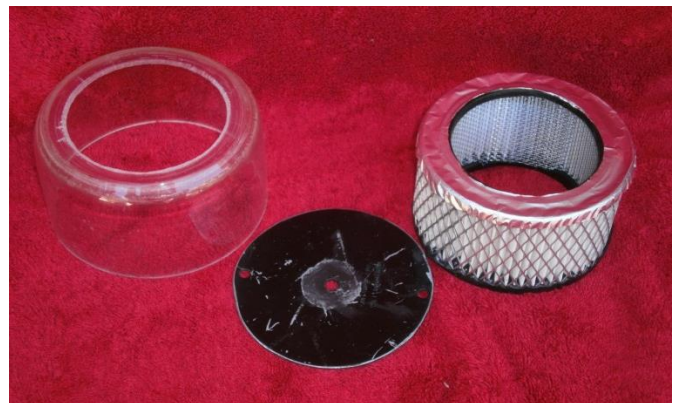
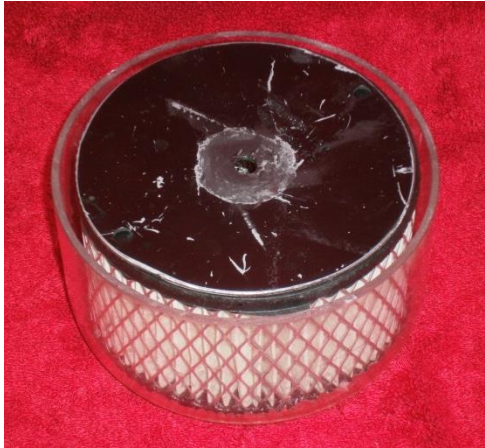
After first assembling the parts, and taking a test drive, all seemed well. Driving home the next evening, I noticed the bike would not accelerate past about 50 MPH, behaving the same as when the filter was wet—

opening the throttle past cruising at 50 had no effect. When I got home, I looked more closely at the fit between the metal disk that covers the bottom of the filter and saw that the gap between it and the clear cover was very small. So, I ground 1/4" from the diameter of the cover to provide about 3/16" clearance all around. A quick calculation said the cut-down plate leaves just under 2-1/2 square inches of inlet area, and a test drive confirmed the improvement.

After a few weeks, I noticed that the plastic was crazing. It seems the rubbery material of the filter end is not compatible with acrylic, so I made an aluminum foil "gasket" so separate them. That seems to have worked well, though I may still need to replace the cover, as I noticed there are cracks growing from the hole in the bottom when taking these photos. If I make another, I will be more careful when drilling, or maybe sawing the hole some other way, to make a smoother cut. My hole saw is a bit savage and I rushed the job. I think any small crack from drilling will grow due to the vibration of the mighty Bullet 500.
